Westinghouse Throttle Valve Seat Upgrade

WESTINGHOUSE THROTTLE VALVE SEAT UPGRADE

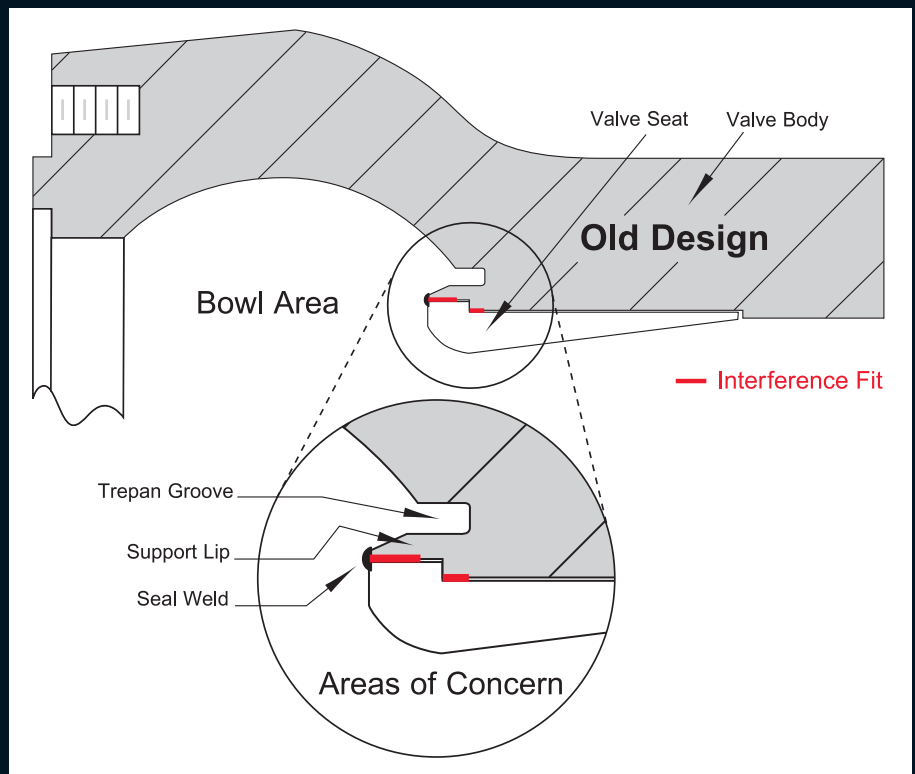
The original seat is held in position and aligned by a ½" to ¾" thick support lip that protrudes out from the trepan groove (OD) and seat bore (ID). The seat is shrunk into this fit and is seal welded in place. The seat to casing shrink fits are all at the inlet end, while the seat tail end is unsupported. This original design puts a tremendous amount of differential expansion and mechanical forces on the localized and thin support lip area.

During cyclic operation, the lower mass seat will thermally expand and contract faster than the massive valve chest, causing the support lip welds to fatigue crack over time. The differential expansion between the seat and valve casing reduces the shrink fit which in turn puts more stresses onto the seal weld. Once the seat loses its interference fit, the seat is only being held in place by the seal weld. The seal weld by design is only meant to hold the seat in place during a severe thermal cycle, where the seat could (for a short period of time) lose its shrink fit. The cross-sectional area of the seal weld is not thick enough to permanently hold the seat in place without the shrink fit. This is what causes the seal weld to crack.

Also, after the seal weld is cracked the seat can move, resulting in steam leakage between the seat and the casing and also between the seat and disc. The yielding of the lip also puts bending stresses into the trepan groove area resulting in cracking.
