# BOWED ROTOR STRAIGHTENING

**TURBINE CONSULTANTS®**

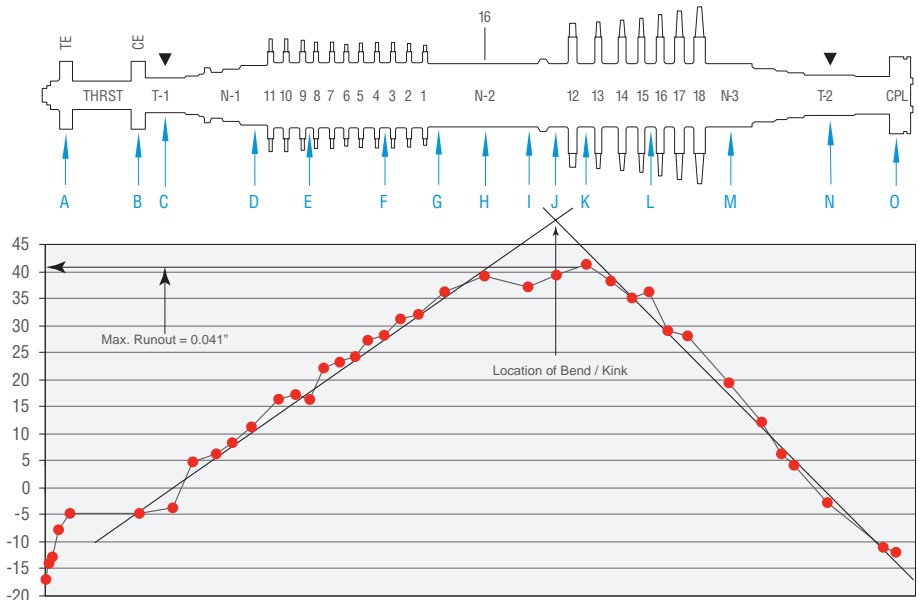
Rotor as found shaft runout measurements, taken on rollers at the journal bearings.

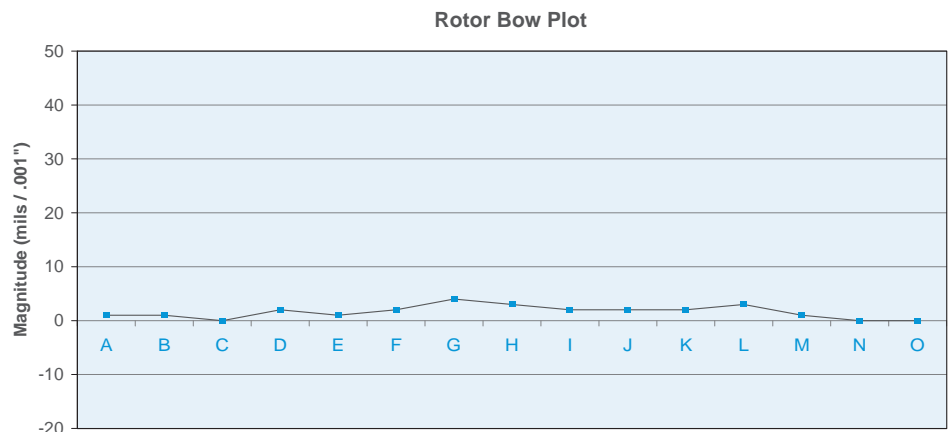
Runout measurement after rotor was straightened using only heat treating methods. No machining required.
