WESTINGHOUSE THROTTLE VALVE SEAT UPGRADE

TURBINE CONSULTANTS®

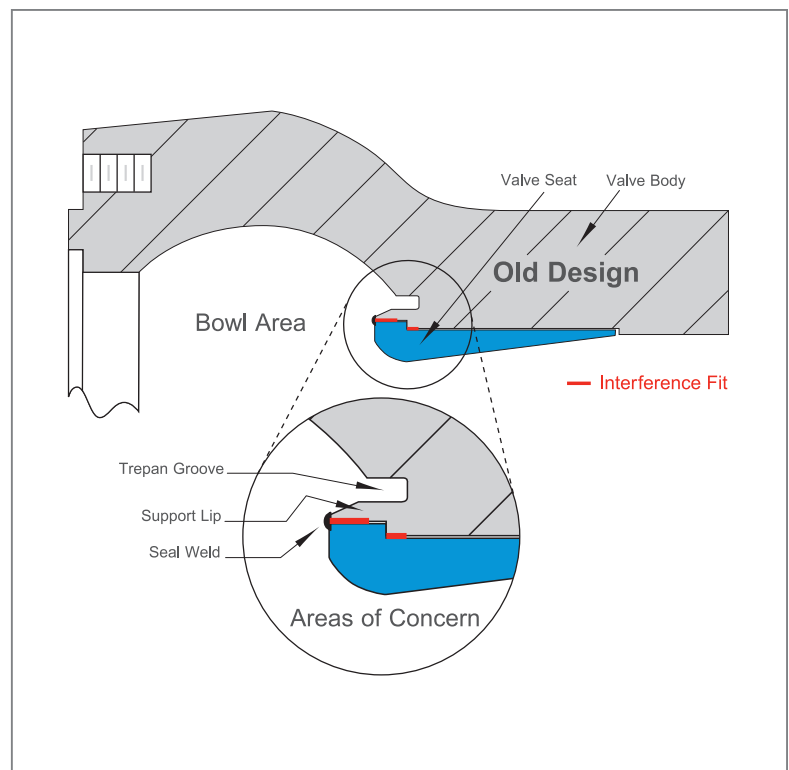
The original seat is held in position and aligned by a $\frac{1}{2}$ " to $\frac{3}{4}$ " thick support lip that protrudes out from the trepan groove (OD) and seat bore (ID). The seat is shrunk into this fit and is seal welded in place. The seat to casing shrink fits are all at the inlet end, while the seat tail end is unsupported. This original design puts a tremendous amount of differential expansion and mechanical forces on the localized and thin support lip area.

During cyclic operation, the lower mass seat will thermally expand and contract faster than the massive valve chest, causing the support lip welds to fatigue crack over time. The differential expansion between the seat and valve casing reduces the shrink fit which in turn puts more stresses onto the seal weld. Once the seat loses its interference fit, the seat is only being held in place by the seal weld. The seal weld by design is only meant to hold the seat in place during a severe thermal cycle, where the seat could (for a short period of time) lose its shrink fit. The cross-sectional area of the seal weld is not thick enough to permanently hold the seat in place without the shrink fit. This is what causes the seal weld to crack.

Also, after the seal weld is cracked the seat can move, resulting in steam leakage between the seat and the casing and also between the seat and disc. The yielding of the lip also puts bending stresses into the trepan groove area resulting in cracking.
