GENERATOR ROTOR WEDGE SLOT DOVETAIL

Inspection And Repair Options

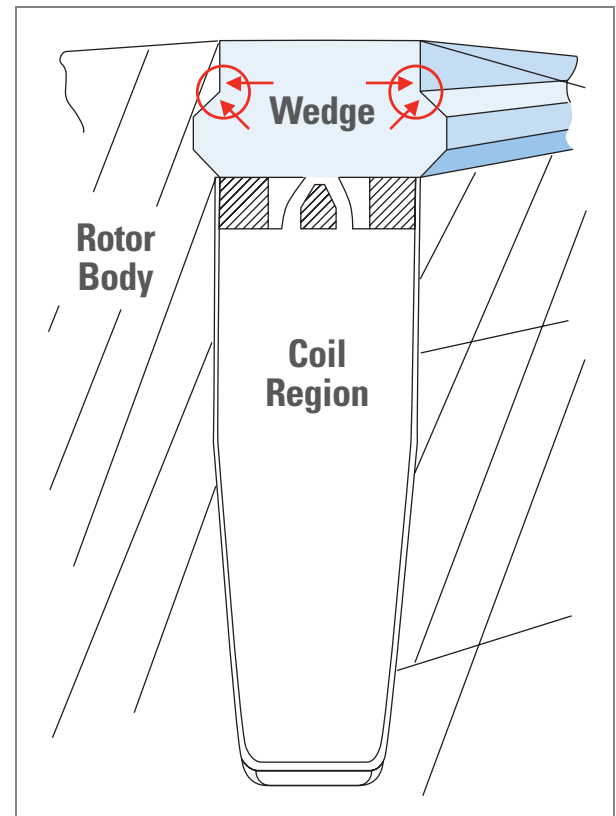
Crack indications located along the wedge loading surfaces are the result of a combination of factors. These include fretting created at the butt-ends of the field wedges, excessive starts / stops, and cyclic stresses resulting from rotor "bending" while on turning gear. Negative sequence current events have also been found to aggravate the effects.

Indications and cracks have been detected in the dovetail region of generator field forging. Areas most likely affected include loading surfaces at wedge butts as indicated in the above illustration by red arrows.

- Work can be performed at the owner's site or in our St. Louis repair facility
- Remove retaining rings and slot wedges, as needed
- Visual inspection of all rotor dovetail surfaces and wedges
- NDE of wedge slot dovetail load surfaces using Eddy Current Testing
- Replacement of steel wedges with newly designed aluminum wedges which incorporate larger end radii
- Redesign of wedge lengths when appropriate to move the location where fretting can occur
- Machining of the affected load surface areas to remove indications, if any, and / or provide increased reliability when appropriate
