Cause and Effect of Rotor Bowing

**BOWED ROTOR
 STRAIGHTENING**
 by
**TURBINE
 CONSULTANTS®**

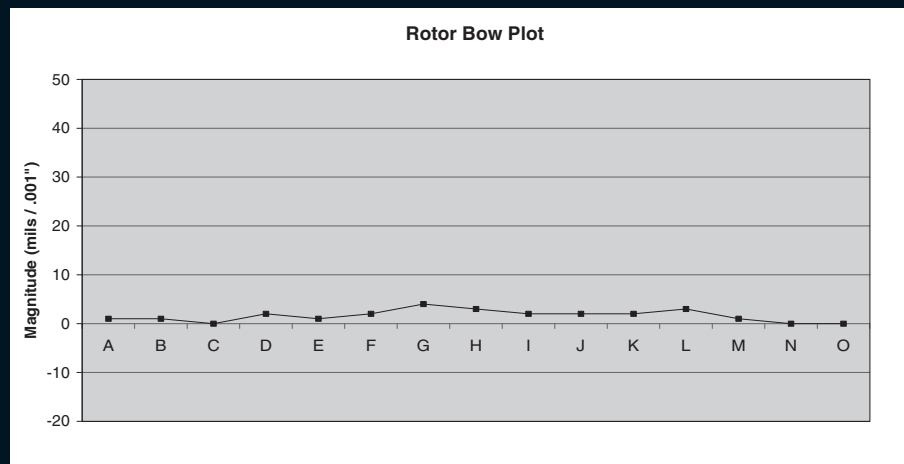
Above: Rotor as found shaft runout measurements, taken on rollers at the journal bearings.
Below: Runout measurement after rotor was straightened using only heat treating methods. No machining required.
