# BOWED ROTOR STRAIGHTENING

By Mechanical Dynamics & Analysis

## Cause and Effect of Rotor Bowing

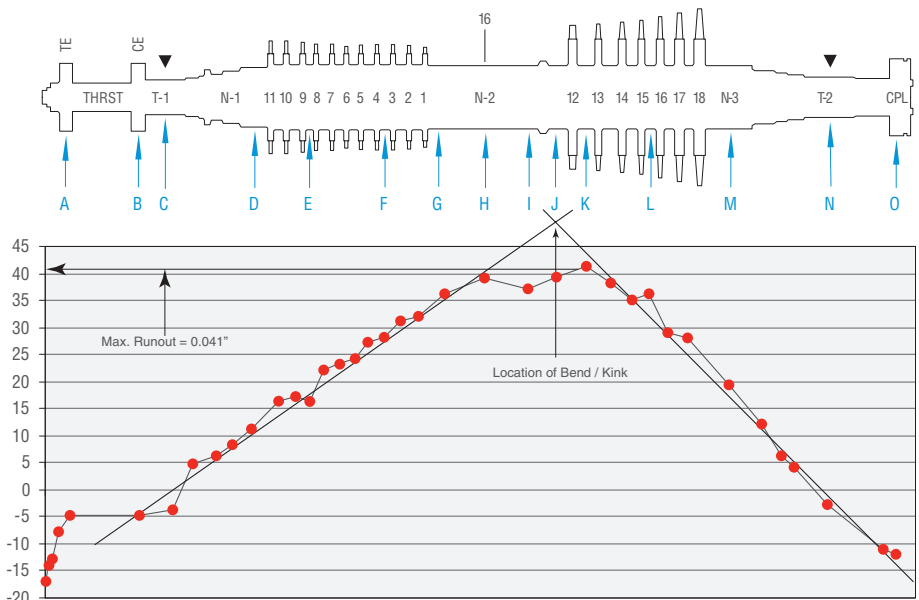
Rotor as found shaft runout measurements, taken on rollers at the journal bearings.

Some bows may partially relax out after the temperature equalizes and the rotor fully cools, while others may remain excessive and then show signs of eccentricity while operating on turning gear. When bows do occur, measuring the shaft runout in a lathe is the best way to quantify the magnitude and the location of these bowed regions.

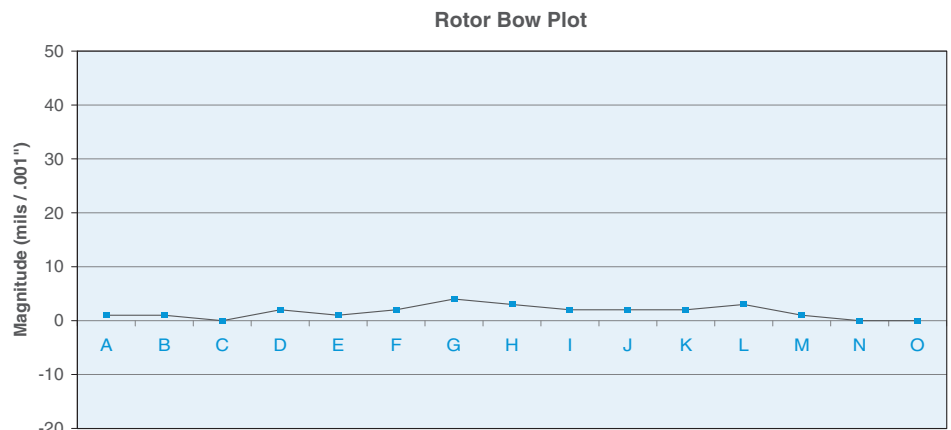
Runout measurement after rotor was straightened using only heat treating methods. No machining required.

The horizontal and vertical methods typically utilize heat treat cycles to reduce shaft bowing and any excess hardness. MD&A prefers to perform sufficient straightening with the horizontal or vertical methods to avoid extensive dimensional compromises, mating parts replacement and follow up site work.
