WESTINGHOUSE THROTTLE VALVE SEAT UPGRADE

By Mechanical Dynamics & Analysis

The generic problems associated with the original Westinghouse designed Throttle Valve seat have been solved, applied and proven in service by MD&A.

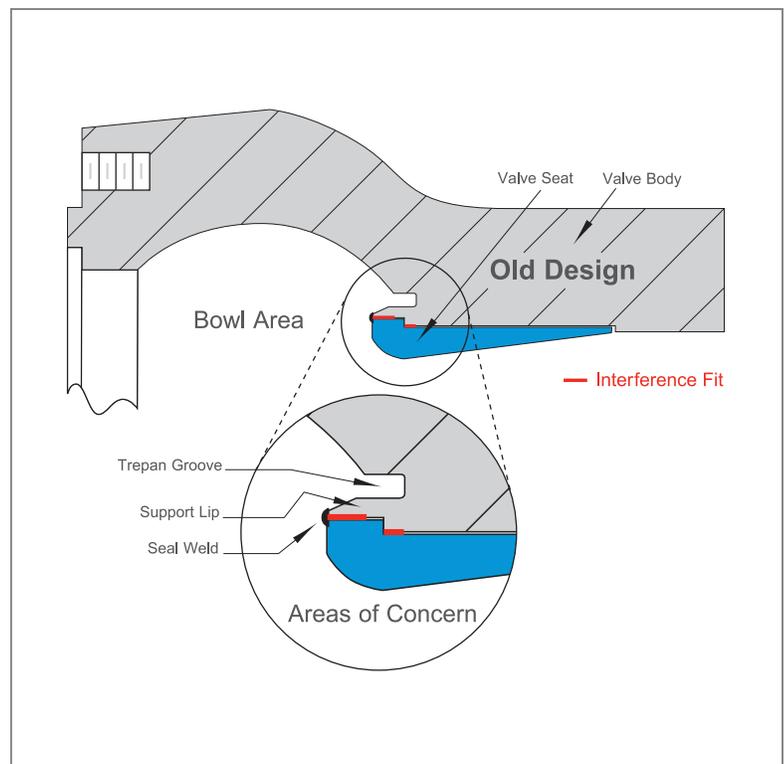
The original seat is held in position and aligned by a $\frac{1}{2}$ " to $\frac{3}{4}$ " thick support lip that protrudes out from the trepan groove (OD) and seat bore (ID). The seat is shrunk into this fit and is seal welded in place. The seat to casing shrink fits are all at the inlet end, while the seat tail end is unsupported. This original design puts a tremendous amount of differential expansion and mechanical forces on the localized and thin support lip area.

During cyclic operation, the lower mass seat will thermally expand and contract faster than the massive valve chest, causing the support lip welds to fatigue crack over time. The differential expansion between the seat and valve casing reduces the shrink fit which in turn puts more stresses onto the seal weld. Once the seat loses its interference fit, the seat is only being held in place by the seal weld. The seal weld by design is only meant to hold the seat in place during a severe thermal cycle, where the seat could (for a short period of time) lose its shrink fit. The cross-sectional area of the seal weld is not thick enough to permanently hold the seat in place without the shrink fit. This is what causes the seal weld to crack.

Also, after the seal weld is cracked the seat can move, resulting in steam leakage between the seat and the casing and also between the seat and disc. The yielding of the lip also puts bending stresses into the trepan groove area resulting in cracking.

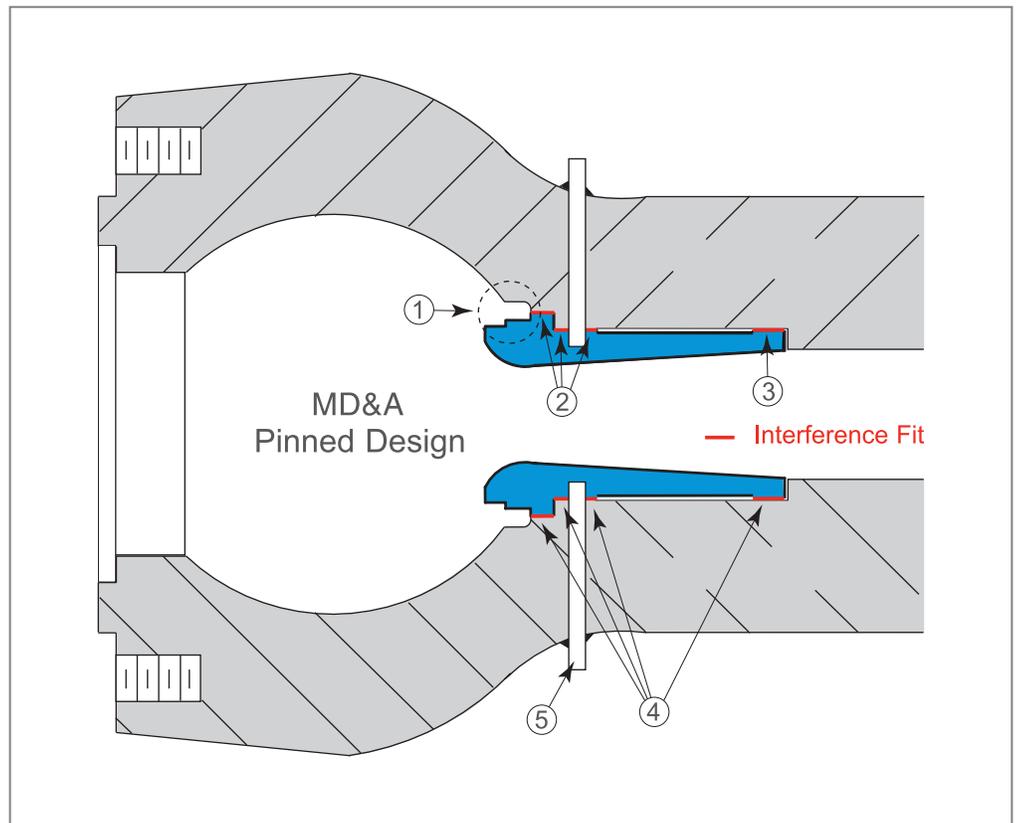
The tested and proven MD&A “Pinned Seat” design eliminates all the generic problems associated with the original seat design and incorporates the following benefits by:

- 1) Eliminating the support lip and most of the trepan groove, thereby removing trepan groove stress concentration areas
- 2) Moving the seat interference fits further downstream into the chest, where the chest wall is thicker and will not yield, helping to eliminate future trepan groove cracking

- 3) Adding an interference / sliding fit to the tail end of the seat, which greatly reduces the stresses on the front end shrink fits
- 4) Increasing the new seat-to-casing interference contact area, equalizing stresses along the body and reducing overall stresses on the front-end interference fits

- 5) Adding multiple radial pins which take the place of the seal weld as noted in the original design. These radial pins not only hold the seat in-place during severe thermal cycling but also eliminate differential expansion cracking problems along the old seal weld by eliminating the need for the seal weld altogether
